# **FREYSSINET INDIA**

# The Freyssinet Prestressed Concrete Co. Ltd.

**w**ww.fpccindia.com freyssinet@fpccindia.com **Corporate Profile 2022**

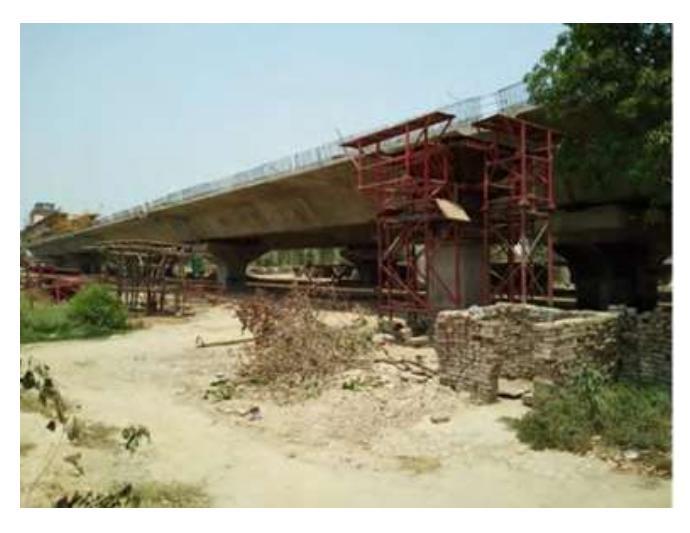
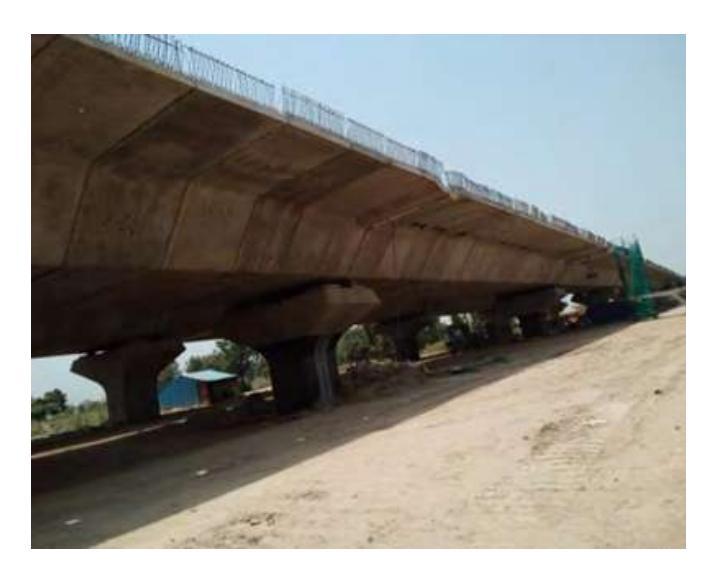
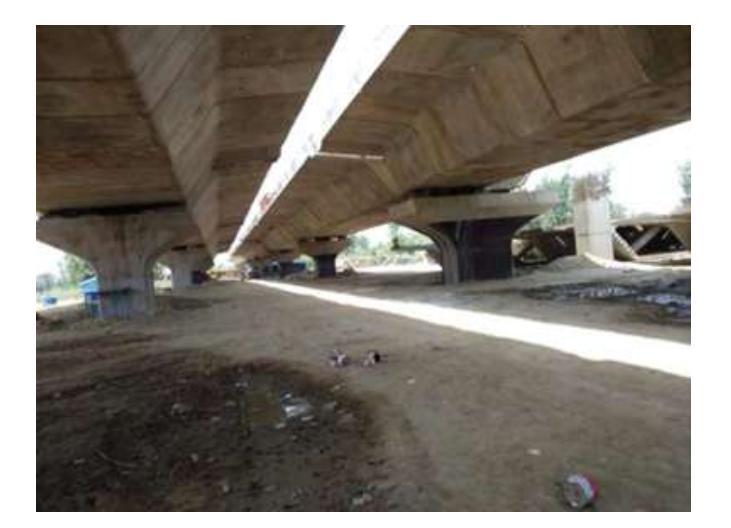
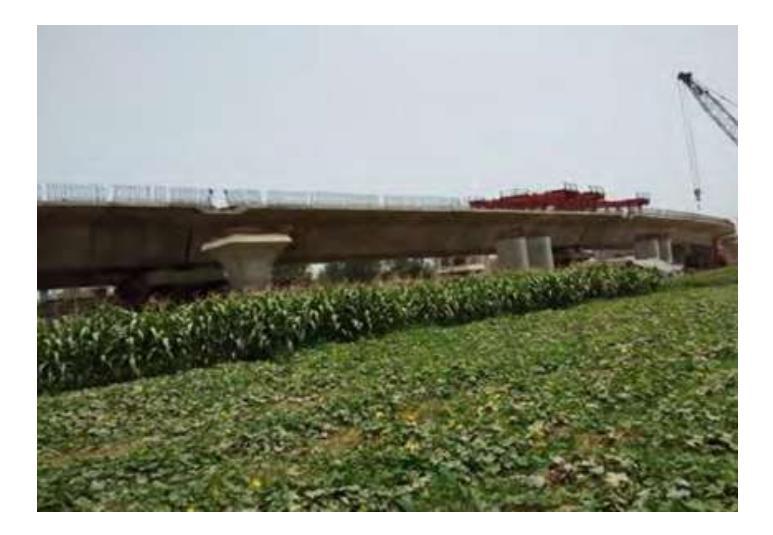
### Barapullaha Bridge, New Delhi

- Length of Corridor : 6.00Km.
- Total Nos. of SPAN : 210 Nos.
- Length of span: 25 to 45 mtr
- Nos. of Pier Cap : 450
- Total Nos. of segment : 2850 Nos

- (A) 19K15 : 5150Nos.(B) 12K15 : 3516 Nos.
- H.D.P.E. Duct 107 mm: 92400 RM
- H.D.P.E. Duct 84 mm: 54000 RM
- Average Time Cycle of PER SPAN: 03 DAYS (Threading & Stressing
- Maximum Stressed in 01 Month = 100 MT

• This was a cable stay bridge and having a 45mtr long span. Pre - stressing activities were carried out simultaneously at multiple locations of simply supported spans of length 45mtr (18MT) in record 3 days so as to meet the time cycle of the project.

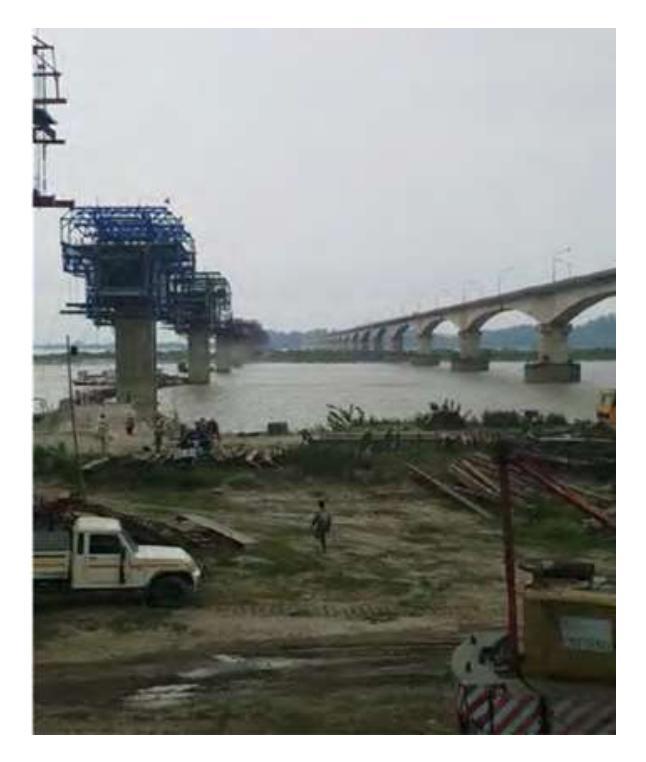
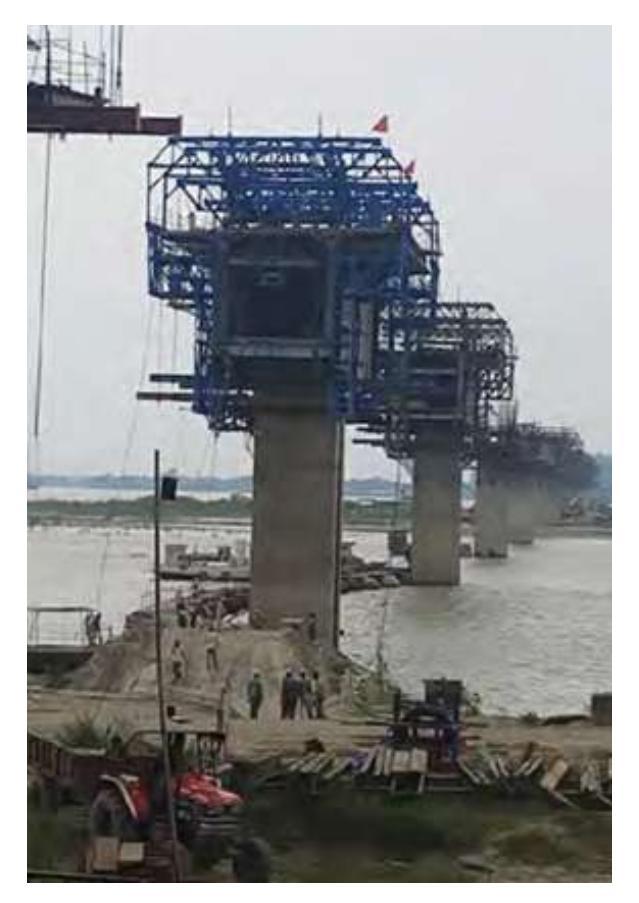
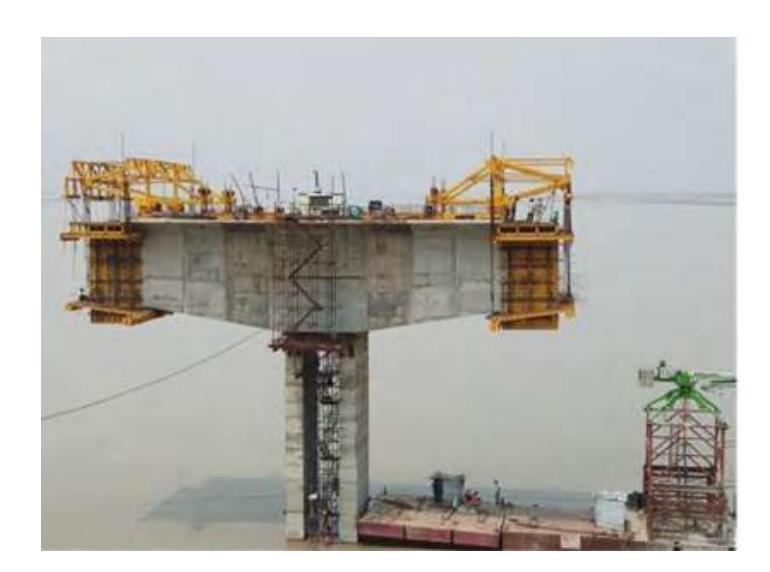
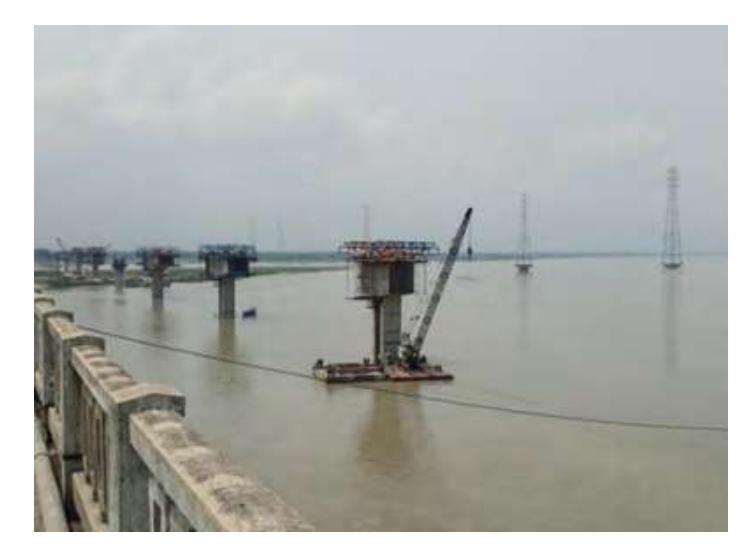
### Brahmaputra Bridge, Assam

- Length of the Bridge: 3.015 Km.
- Bridge consist of 9 modules and have 27 pier.
- Length of the Span: 120m
- Construction method : Cast in Situ Balance Cantilever
- Post Tensioning system used is Freyssinet 19K15 and 12K 15

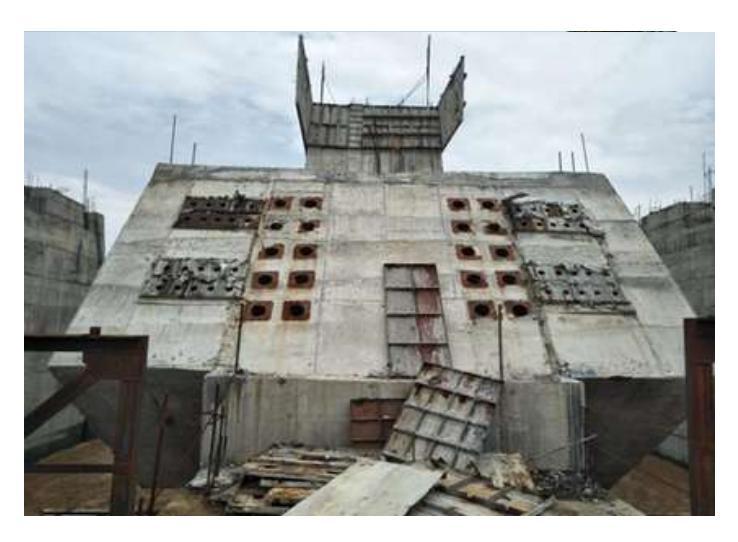
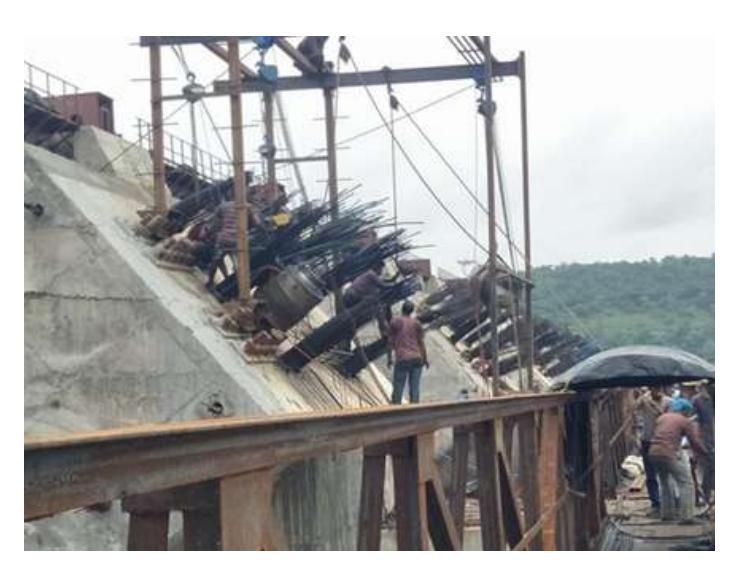
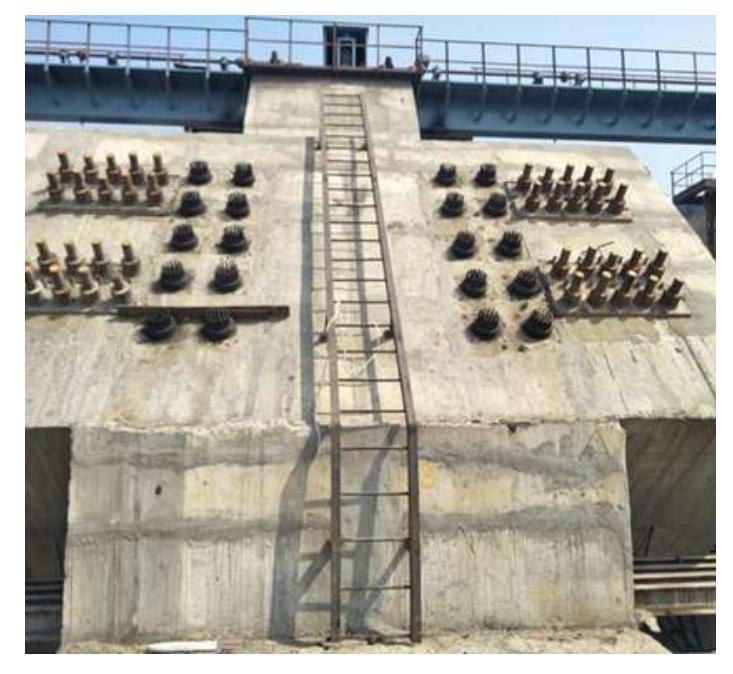
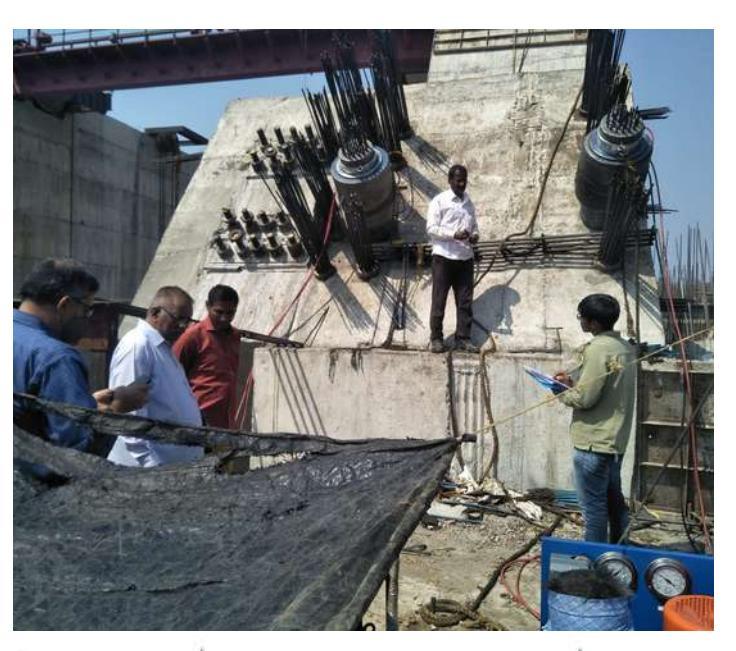
# Prestressing of Radial Gates of Thupakulagudem Barrage Project, Telangana

- Freyssinet system of 27K15 & 12K15 was used on piers of radial gates.
- Strands used are of PE coated of 15.2 mm diameter.
- Total quantity of tendons 750 MT, among which 660 Nos are transverse tendons and 1222 Nos, are Longitudinal tendons.

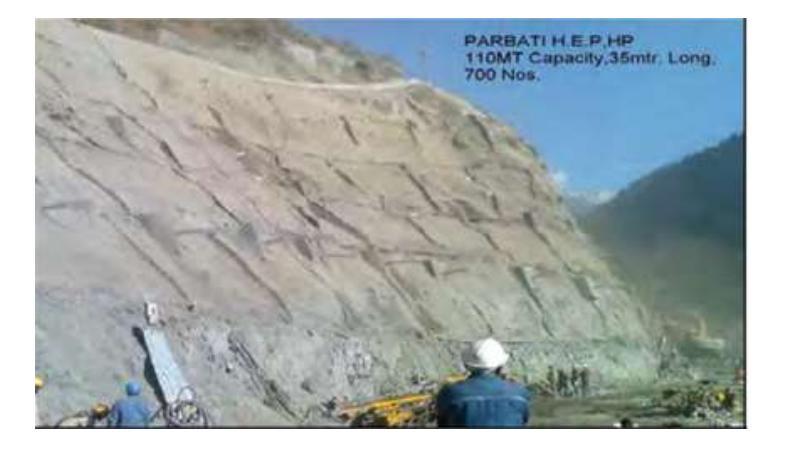
## Parbati Hydroelectric Project, Himachal Pradesh

- **Details**: The project is located in the hilly terrain of Kullu.
- **Challenge:** During construction of the power house a portion of the slope behind the power house collapsed. The slopes were to be stabilized to prevent further landslides and caving.
- **Solution:** A system of prestressed anchors and rods was devised to stabilize the slopes. Freyssinet 12K13 tendons were used. Shortcreting was done on the slopes after anchoring of the tendons to prevent damage to the slopes due to water. A total area of 90 meter x 175 meter was stabilized in this manner.

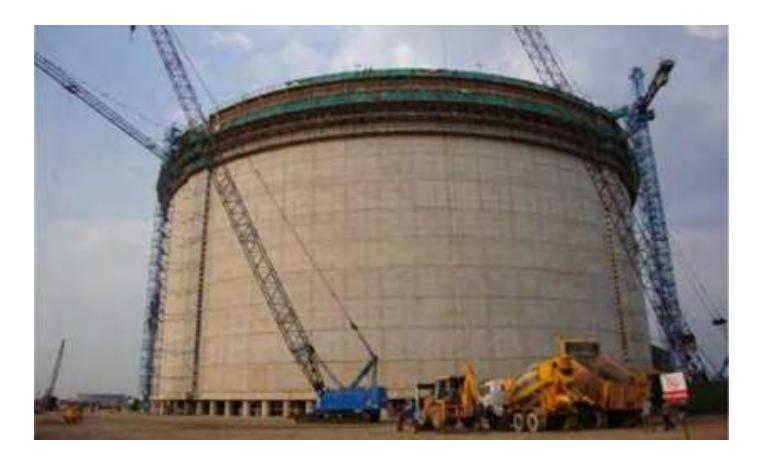
### LNG Storage Tank at Kochi, Kerala

- Height: 41 MTR
- **Prestressing System:** Freyssinet 19K15 for Horizontal & 12 K 15 for Vertical Tendons.
- Storage Temperature: 165 degree
- Year: 2011

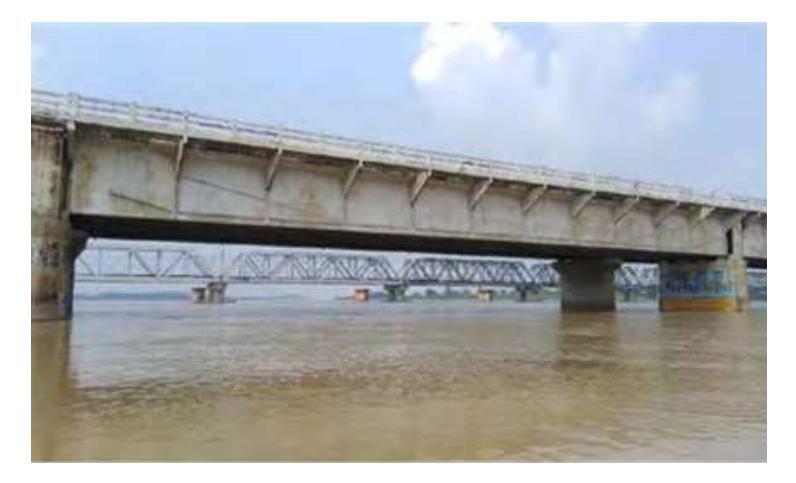
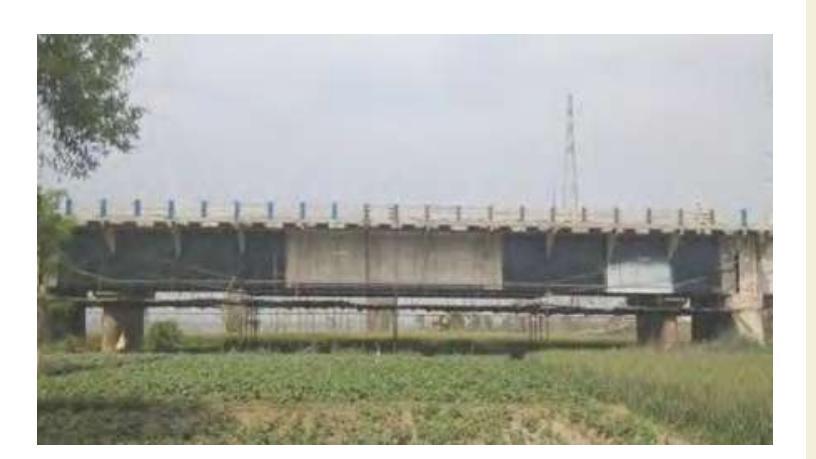
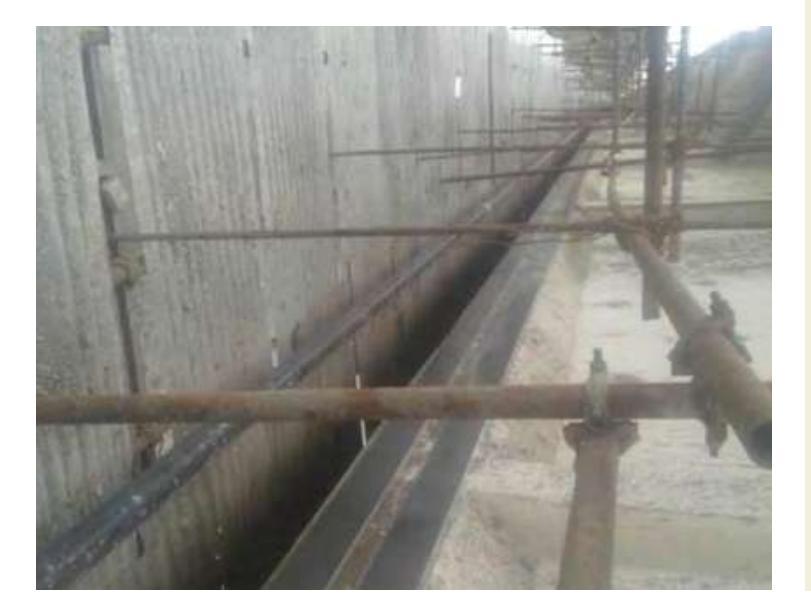
### Ganga Bridge, Moradabad - Uttar Pradesh

- Bridge was shown distresses in the rocker and sliding bearings, cracks in the superstructure.
- Existing strip seal Expansion joints had become Non functional.
- Deflection in the centre of spans observed due to loss of pre stress level in the existing cables.
- Concrete of deck slab was damaged at several locations and pot holes observed in the deck slab with wearing course.
- Wearing course was damaged in the entire length of bridge. RCC railing, Footpath slab was broken and missing at several locations.
- Concrete brackets supporting to the footpath slabs were broken in the entire length of the bridge

- Drilling of holes, cement grouting was carried out in the super structure.
- Honeycomb concrete was repaired by polymer modified mortar.
- External Prestressing scheme designed after results of Non Destructive tests.
- External prestressing carried out for all the 13 spans by providing 6k15 High tensile tendons as per the approved drawings.
- Laminate and carbon fiber wrapping applied on the girders as per the approved design and drawings.
- All the concrete brackets were repaired by High early Strength Concrete.
- Entire old railing, wearing course replaced by new one
- Anti carbonation painting applied on superstructure

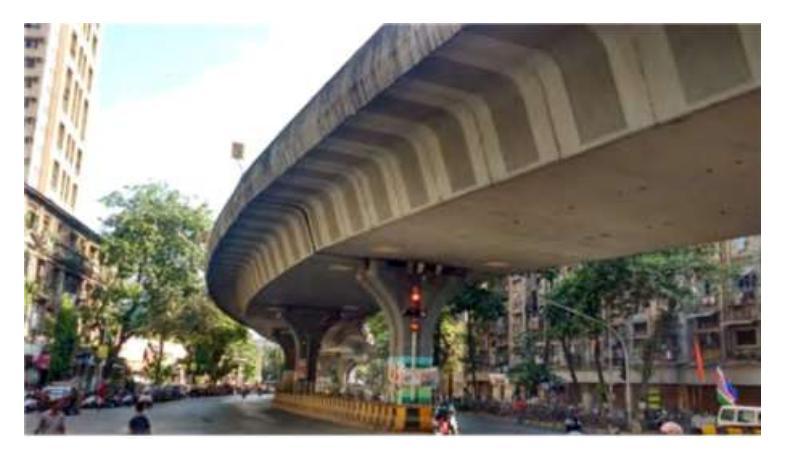
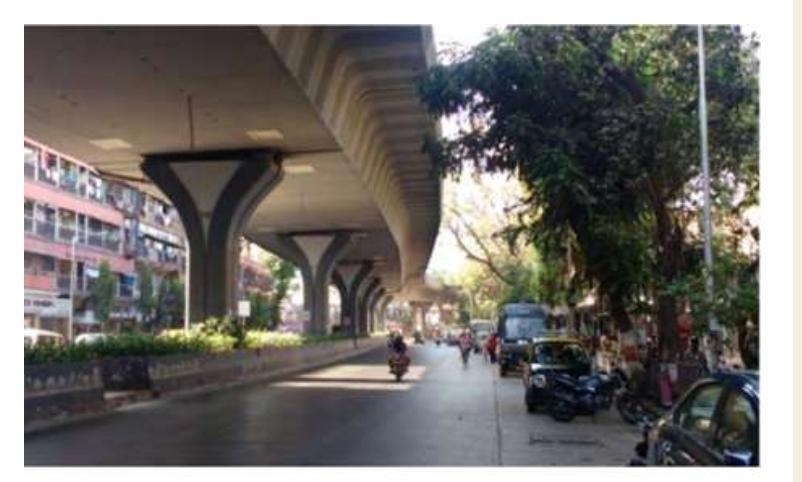
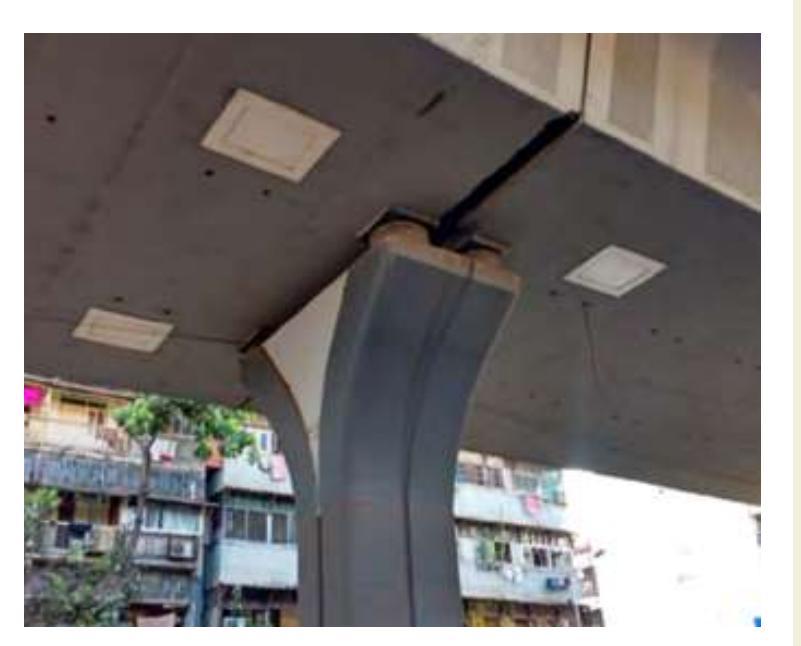
### Lalbaug Flyover, Mumbai - Maharashtra

- Within 7 years from its completion, bridge has shown excessive distresses mainly in POT.PTFE bearings, Expansion Joints, riding surface and cracks in the pier caps, box girders.
- The biggest challenge is to lift the 4 continuous spans at a time with suitable capacity of hydraulic jacks, removal of damaged POT PTFE Bearings and provide new bearings.
- The capacity of bearings is from 400 to 500 MT

- Methodology for safe lifting of 4 Continuous spans to be prepared.
- Removal of old defective bearings will be carried out.
- Fixing of new POT PTFE bearings with time line and level.
- Bridge is to be strengthening by EPS as per design prepared by independent structural consultant and proof checked by IIT Mumbai.
- RCC pier loads and superstructure to be strengthen by applying carbon fiber and laminate as per approved design and drawings.
- All expansion joints are be to replaced by new joints with micro concrete.

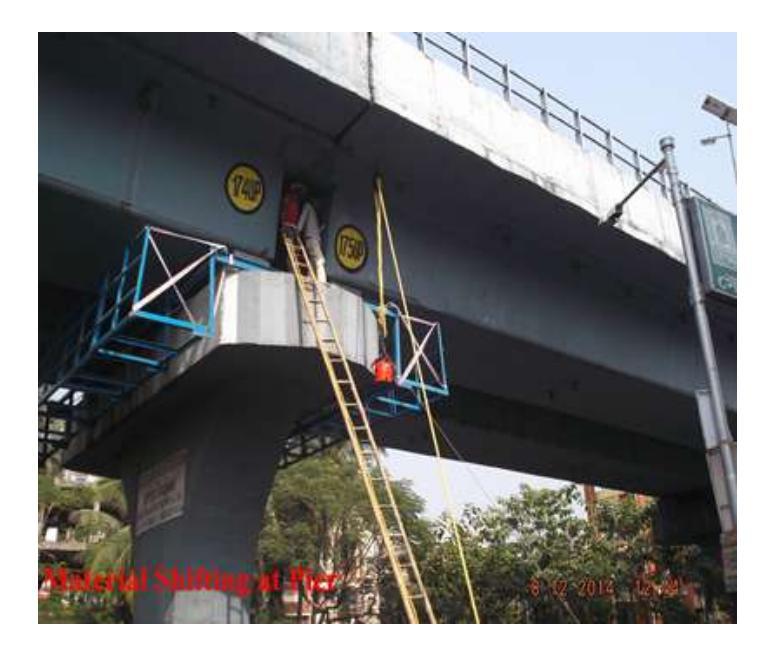
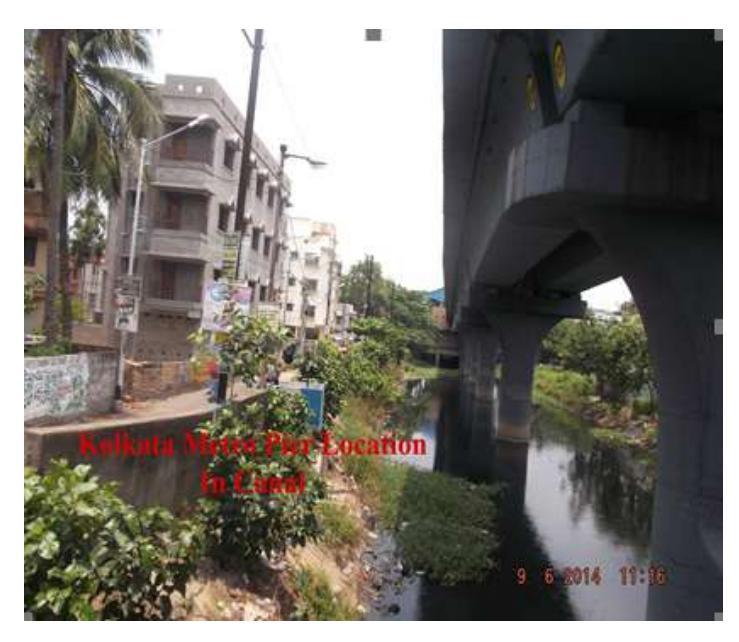
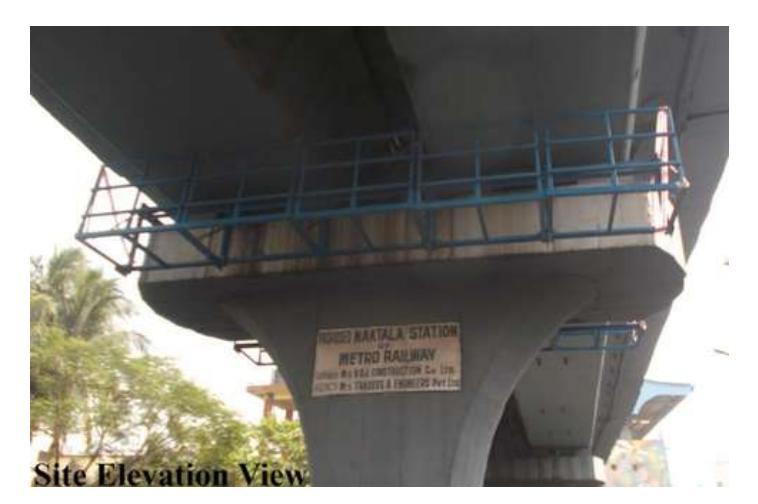
### Kolkata Metro Railway, Kolkata - West Bengal

- During regular service some gaps had been observed in between the top & bottom portion of bearings, soffit of girders and top part of pedestal, resulting in uneven load to the bearings. Few bearings were detected over stressed with signs of budging.
- Viaduct Route Alignment: All piers were located in the centre of Tolly Nullah which was full of city waste water & there was no approach road to place plant and machinery at working location.
- Working Hours: Only 5 Hours was scheduled by Metro Railway at night for Lifting of girder & replacement of bearings with sitting arrangement rectification.
- Daily Operations: It was a big challenge to ensure that daily metro service timing should not be disturbed due to replacement of bearing.
- Materials: Before commencement of work selection of suitable high strength epoxy materials was a big task as it required strength within specified time.

- Successfully replaced all 2752 nos. bearings. Every night 8 bearings were replaced within a 5 hour time period.
- Micro planning of time, deployment of highly skilled manpower and using specific tools in respect of each activity.
- We had designed a special type of steel frame which was a hanging working platform to execute the work at pier cap as it was not possible to erect the platform from ground level due to running sludge in Nallah.
- For the first time in Indian Railways a total of 2752 bearings were replaced without disrupting the daily operations of metro showcasing our incredible credibility.

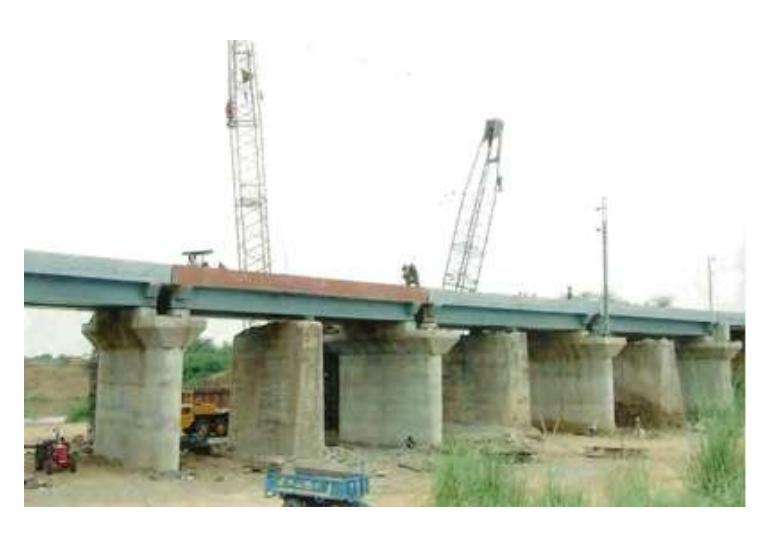
Bridge No.478 - Complete view after launching of all PSC girders

• New pile foundations were laid. The plate girder decking was replaced by prestressed concrete girders. The entire project was executed without disrupting traffic.

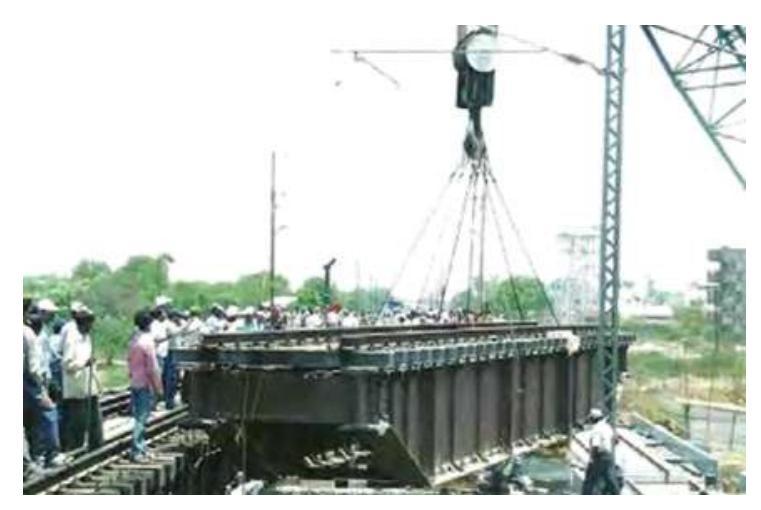
1st Stage - 35 M.T. existing steel girder was delaunched by 400 M.T. capacity hydraulic crane.

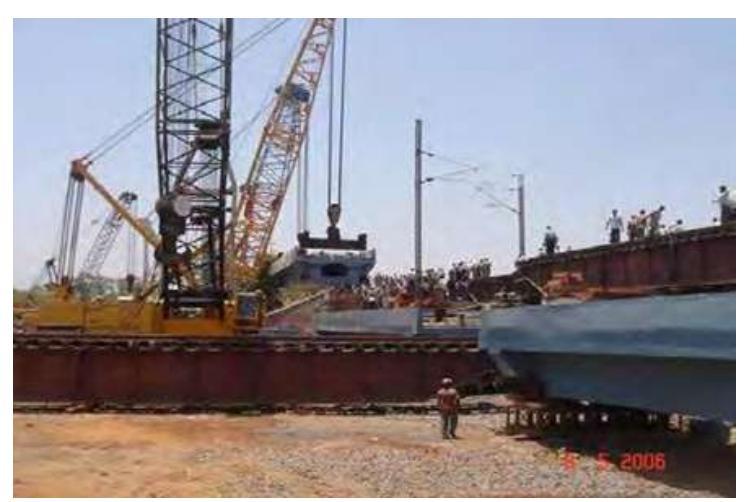
3rd stage – Launching of PSC box girder in progress and is in final stage.

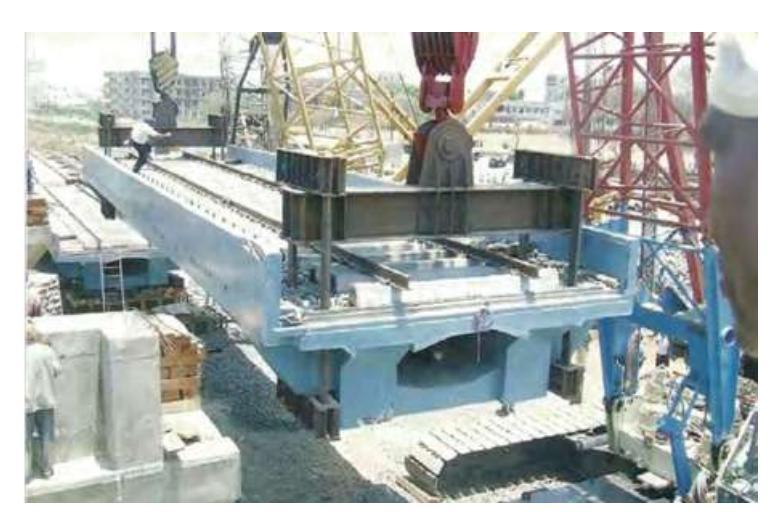
2nd stage - PSC box girder weighing 220 M.T. Lifted using 2 nos. 400MT capacity craneS from ground level

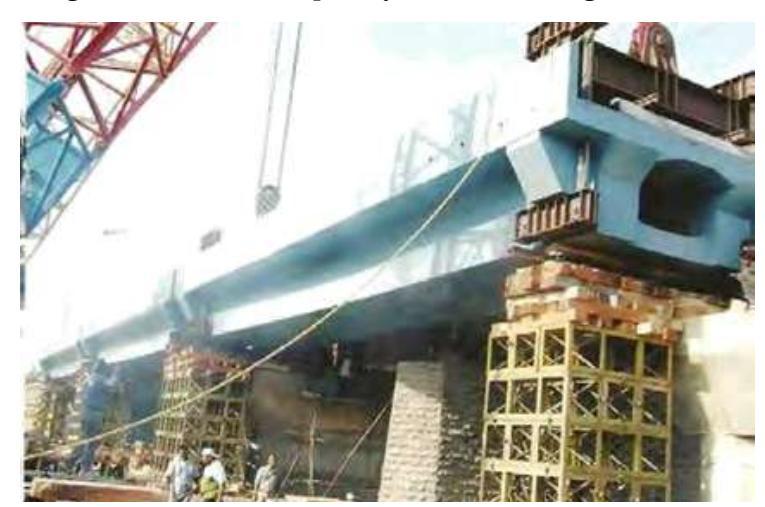
4th & Final stage – View showing PSC box girder placed on Temporary c.c. cribs before finally placing in position on new pier caps.

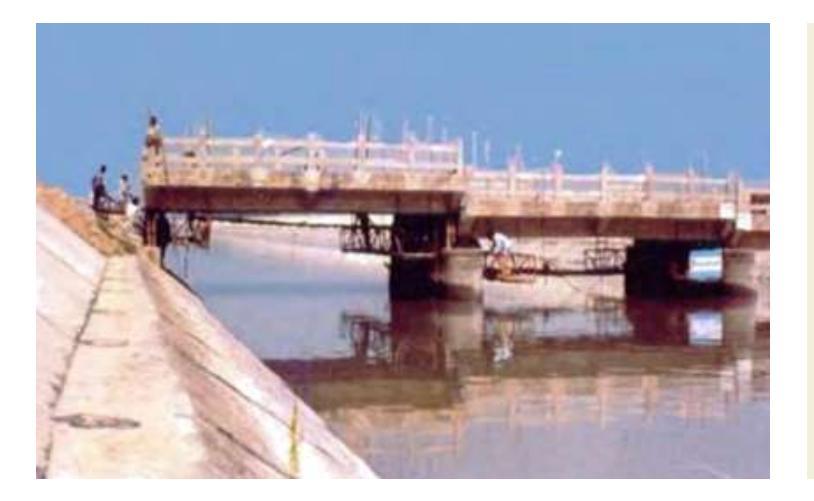
## Sutlej Canal Bridge, Punjab

- **Details:** Some submersible bridges are raised by jacking up the decks and by increasing the height of piers. Rapid growth of urban areas at times, calls for improvement in bridge structures near the city to take care of the network of roads.
- **Challenges:** During the service life of bridge, time had come when the bridge was required to be elevated.
- **Solution:** The decking of Sutlej Bridge over the canal was raised by 1.2 Metres to accommodate higher FSL.

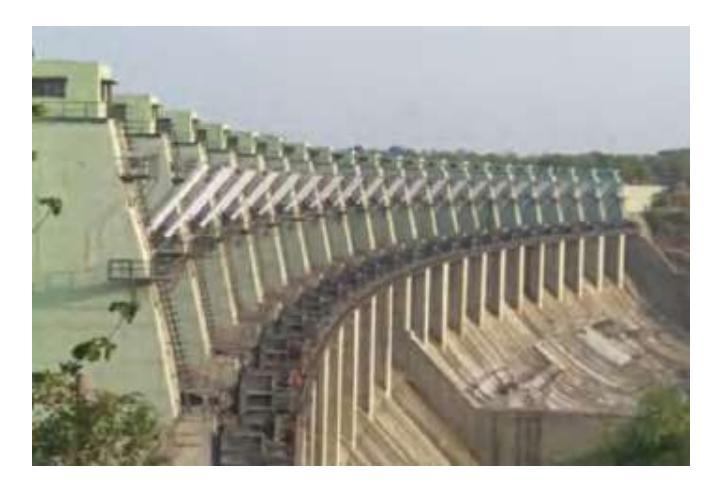
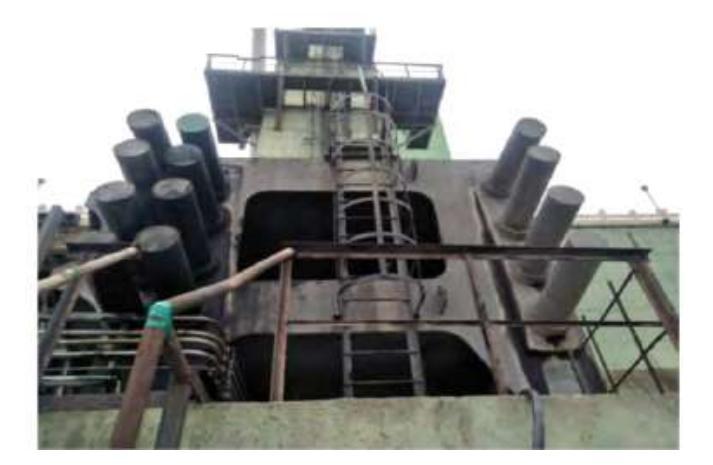
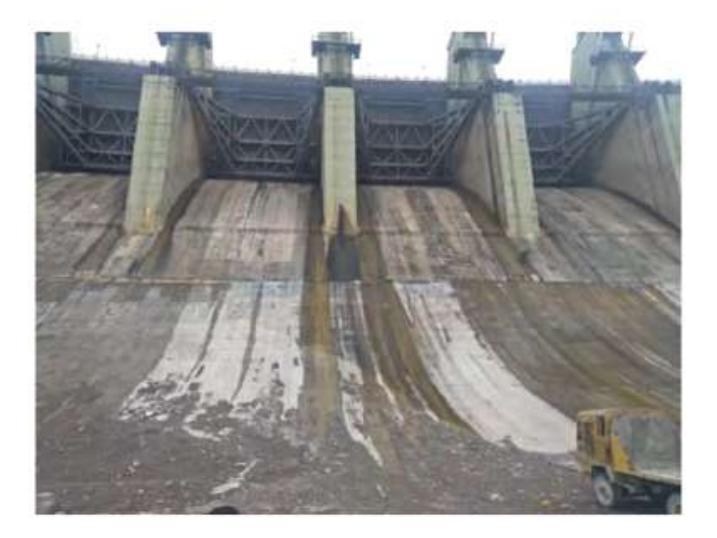
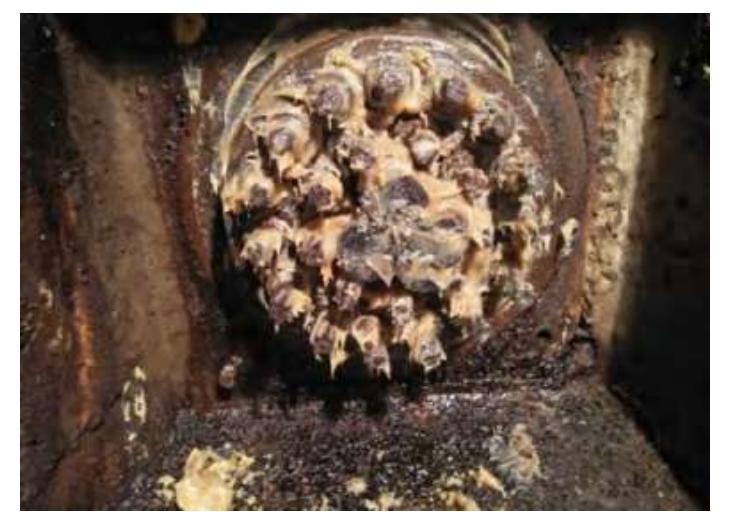
### Indira Sagar Dam, Khandwa - Madhya Pradesh

• There was loss of Pre-stressing force in the existing cables and slippage of strands in few cables observed.

- All the selected cables were opened upto the bearing plates by removing the caps, existing grease was removed and cables were cleaned. The losses of stressing forces restored with re stressing of all the strands as per the design force
- The caps were refitted with filling of new Graphite Grease. Slipped cables were distressed and then re stressed again as per the design load. Grips of both dead and stressing end have been changed.
